CCTV DRAINAGE SURVEY REPORT

CLIENT:	XXXXXXX
SITE ADDRESS:	XXXXX Road London N17
SURVEY:	Foul Drain
DATE:	17th May 2011
JOB REF:	04398 / 060622

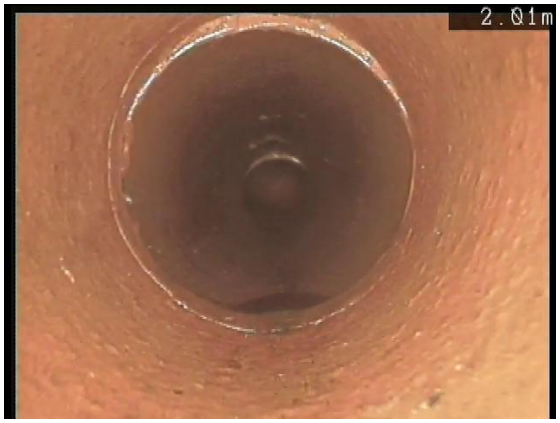
This run was initially blocked by a large build up of congealed grease deposits. We believe this build up was caused due to the roots that were initially protruding through the connection near the start of the run. This area is also cracked and fractured at the joint and the drain shows further cracks plus a small hole in the roof of pipe at 2.3 metres. We recommend this whole run is sealed and strengthened with a structural liner.

R1 blocked (before clean)
